Chippewa Creek – Oak St Channel Repair Class Environmental Assessment Report

**North Bay – Mattawa
Conservation Authority**

**Water's Edge
Environmental Solutions Team Ltd.**

April 16, 2019

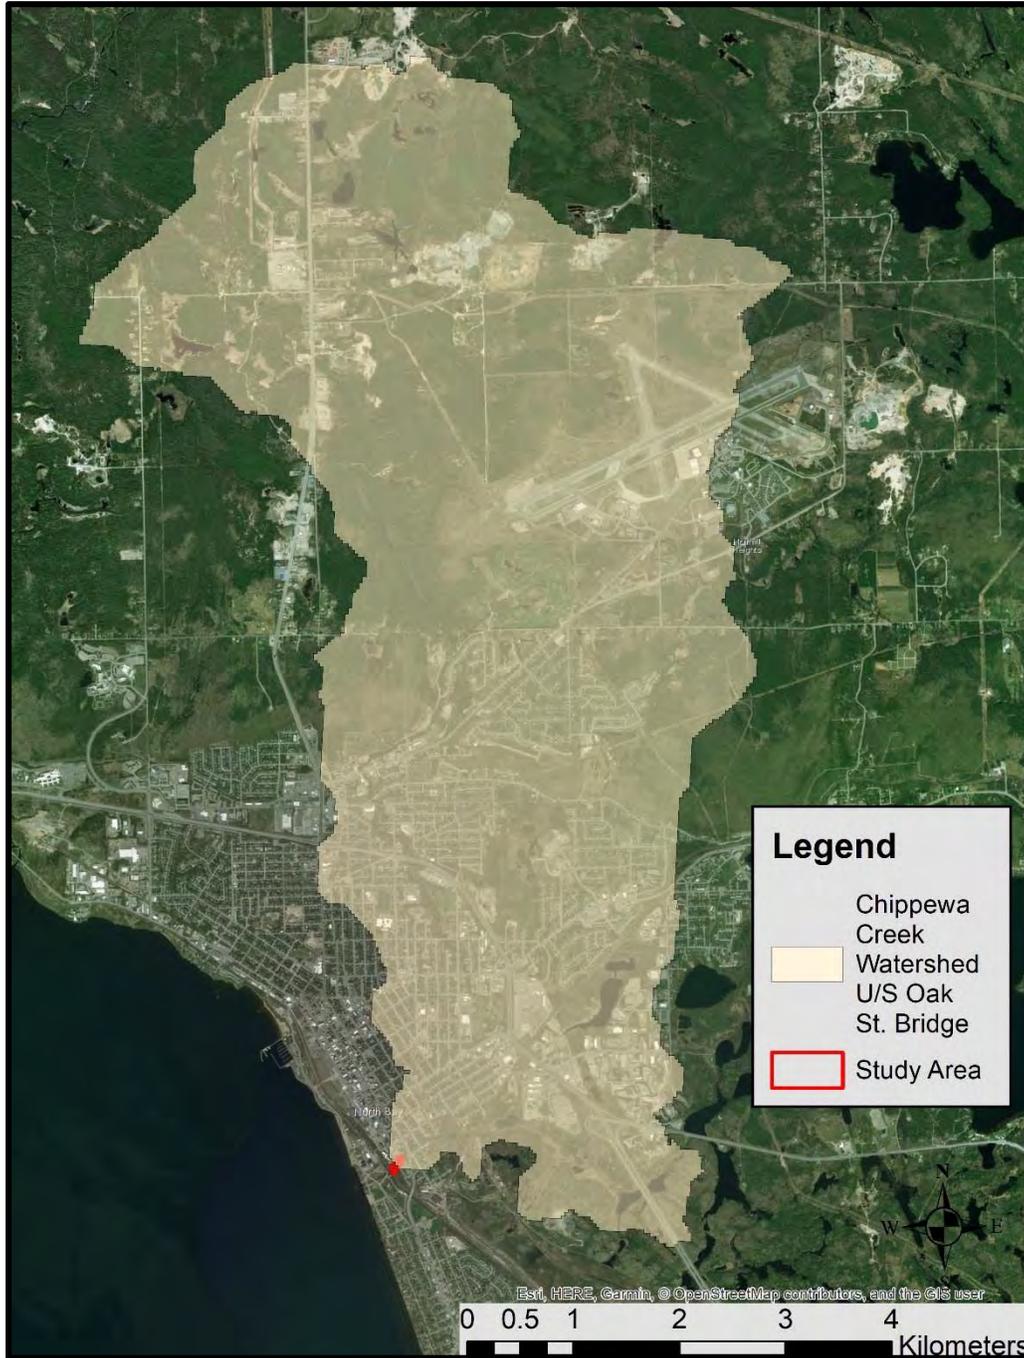
Figure 2: Chippewa Creek Watershed upstream of Oak Street Pedestrian Bridge

The drainage area upstream of the Oak Street Bridge is 38.8 km² according to the Ontario Flow Assessment Tool III (OFAT) and is a third order channel. The main channel is 20.4 km long starting just south of Cooks Mills and flowing south over the escarpment and through North Bay before draining to Lake Nipissing. The average slope of the channel is 0.8%, with steeper reaches present on the escarpment. The landuse is dominated by community/infrastructure (49%), and treed areas (49%).

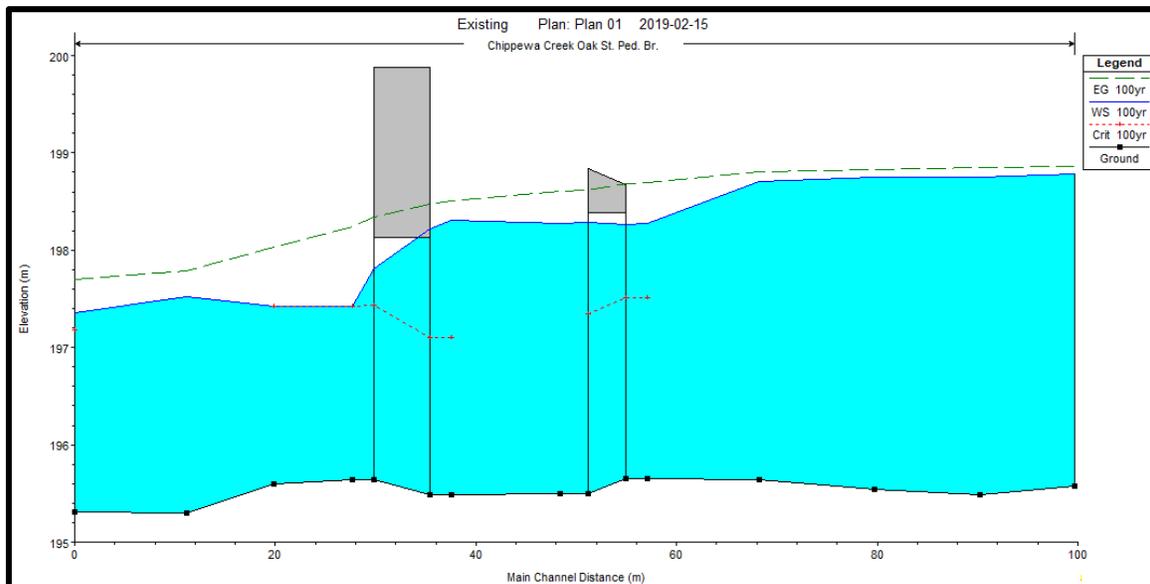
Figure 4: Existing Conditions HEC-RAS model showing the 100-year flood level

The model shows the existing conditions in the reach, which represents the “do nothing” option. The longitudinal profile of this model with the 100-year flood level is shown in **Figure 4**. The WSEL profile shows two distinct drops near each of the structures, indicating that the structures are creating a backwater effect and contributing to the upstream inundation. The WSEL drop downstream of the rail bridge may also create a hydraulic jump. The WSEL profile shows that both the 50- and 100-year floods will over-top the banks just downstream of Main St. in this scenario. Output summary tables for the HEC-RAS modelling are included in **Appendix E**.

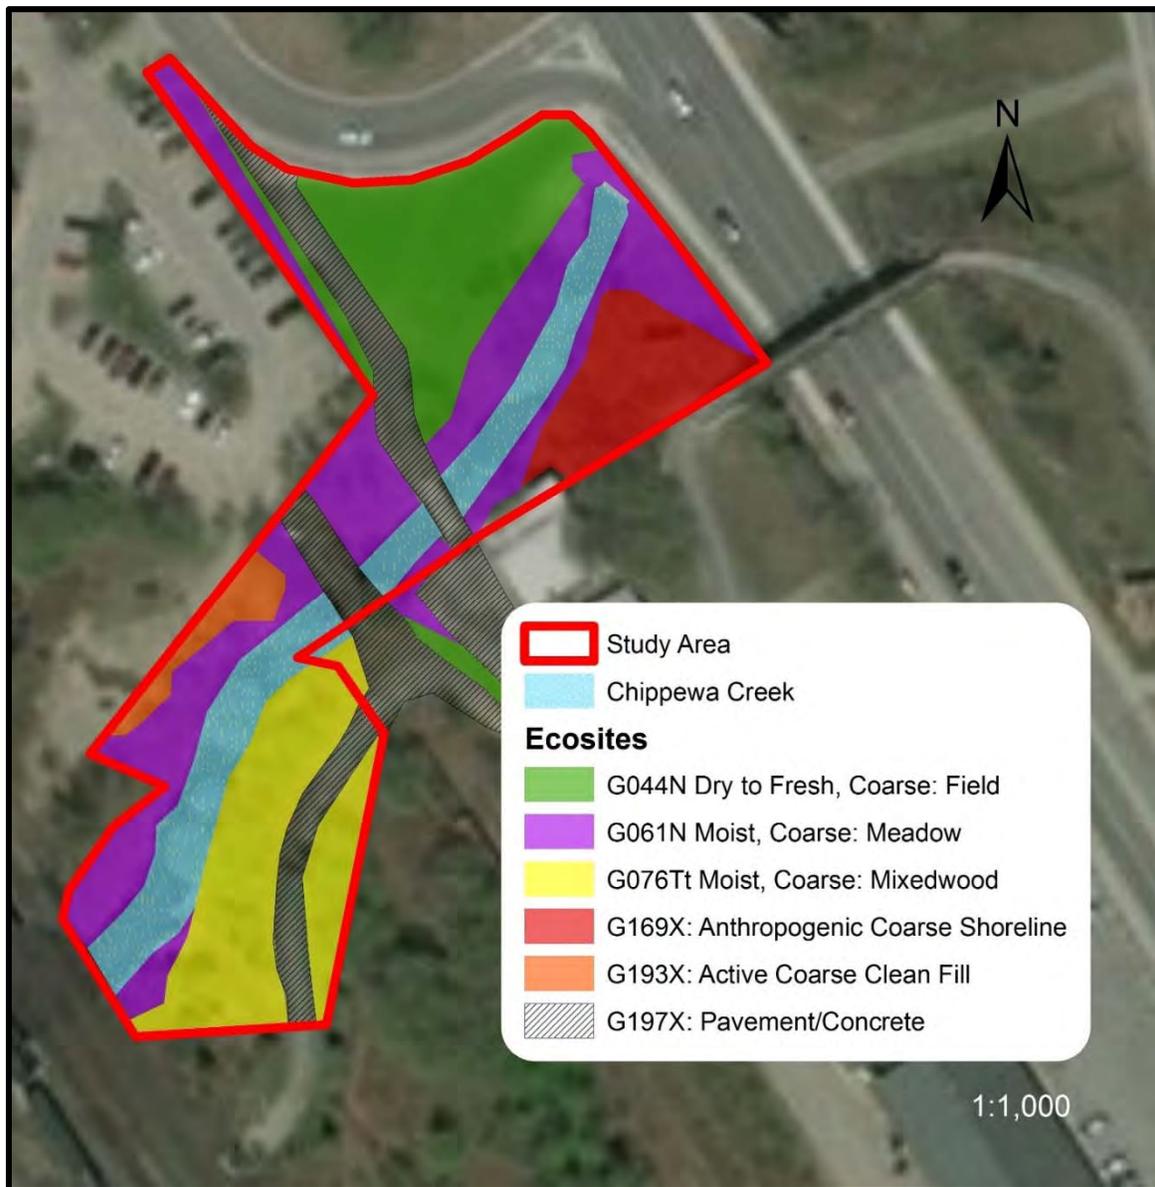
Figure 5: Study Area Ecosites

The biological assessment was conducted by FRiCorp and included an ecological land classification within the study area. The full report is included in **Appendix B** and a summary is provided here. FRiCorp identified six ecosites within the study area, which are shown in **Figure 5**.

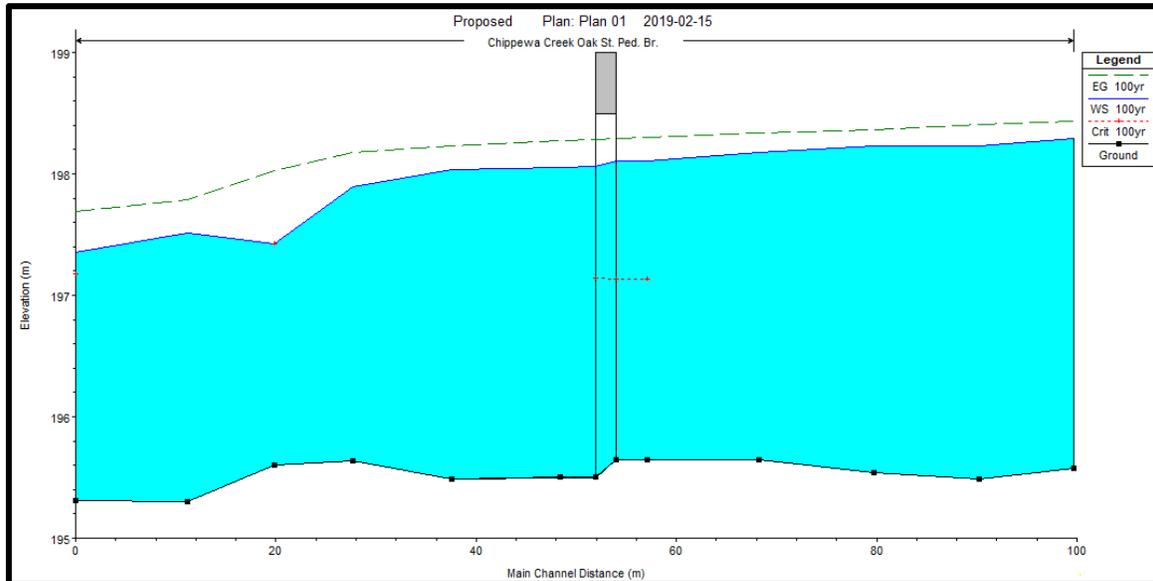
Figure 6: Option 4b HEC-RAS model showing the 100-year flood level

The “proposed” model represents Option 4b, where both bridges are removed, a replacement pedestrian bridge is installed, with bank regrading and stabilization. The longitudinal profile of this model with the 100-year flood level is shown in **Figure 6**. In this scenario, a WSEL drop was observed downstream of the old rail bridge in approximately the same location as the existing conditions model, which suggests that the bed geometry causes the issue and the constriction from the bridge exacerbates it. The improved conveyance as a result of removing the bridges led to the flood levels of the 100-year flood being contained within the channel at all cross-sections. The WSEL immediately downstream of the Main St. culvert are significantly reduced by 49 cm in this scenario.

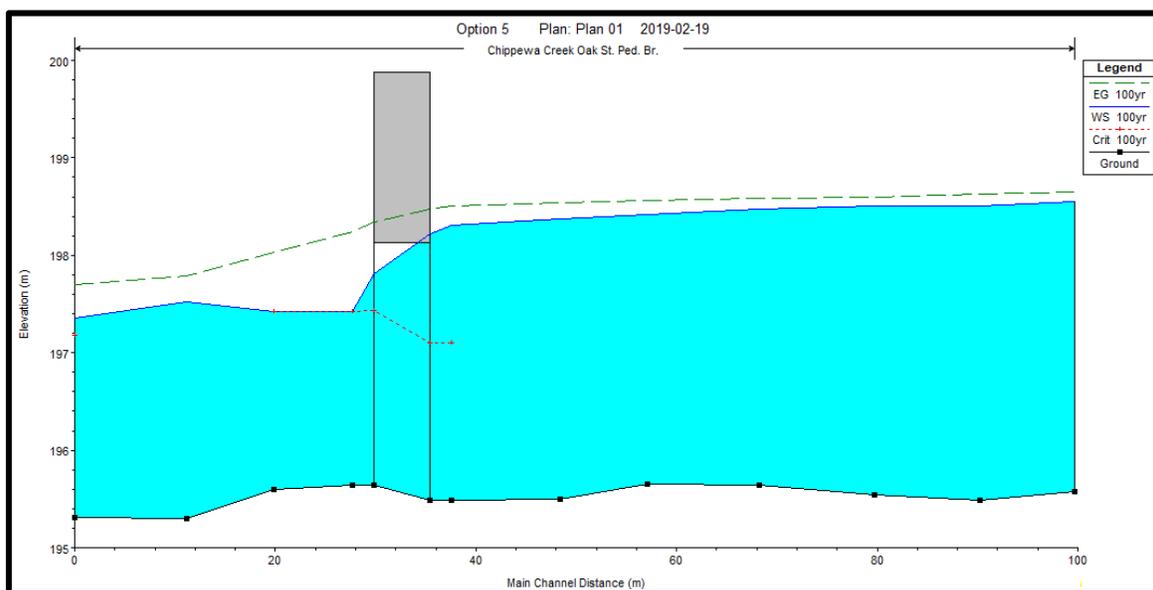
Figure 7: Option 5 HEC-RAS model showing the 100-year flood level

The final model represents Option 5, which was developed to illustrate the effects of removing just the pedestrian bridge and keeping the old rail bridge, an option suggested by Ontario Northland. For this option the pedestrian bridge would be removed, and banks would be regraded or stabilized, while the old rail bridge and surrounding banks would remain as-is. The longitudinal profile of this model with the 100-year flood level is shown in **Figure 7**. When compared to the existing conditions model, the WSEL profile is moderately lower, with a significant WSEL drop after the rail bridge with a likely hydraulic jump. The WSELs immediately downstream of the Main St. culvert are reduced by 23 cm compared to the existing conditions model for the 100-year storm. The WSEL profile is much smoother through this reach, although some cross-sections near the pedestrian bridge or between the two bridges have higher WSELs than the existing conditions model. This phenomenon is due to supercritical flows under the existing bridge and the hydraulic jump downstream of the bridge no longer being present. Despite the higher WSELs in some areas, the 50-year flood is contained within the channel in all cross-sections. The 100-year flood will continue over-top the banks near Main St. in this scenario.

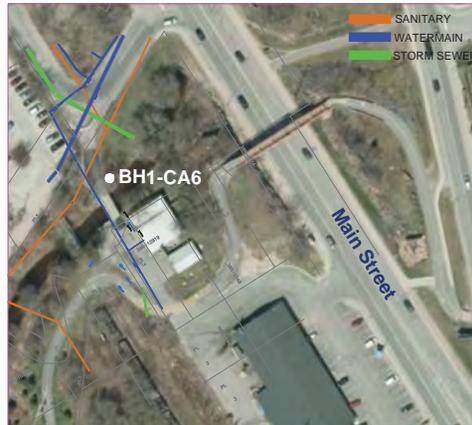
Site1 (CA-6) Located on right bank beside the Oak Street Pedestrian bridge (closed) Silty Sand Fill

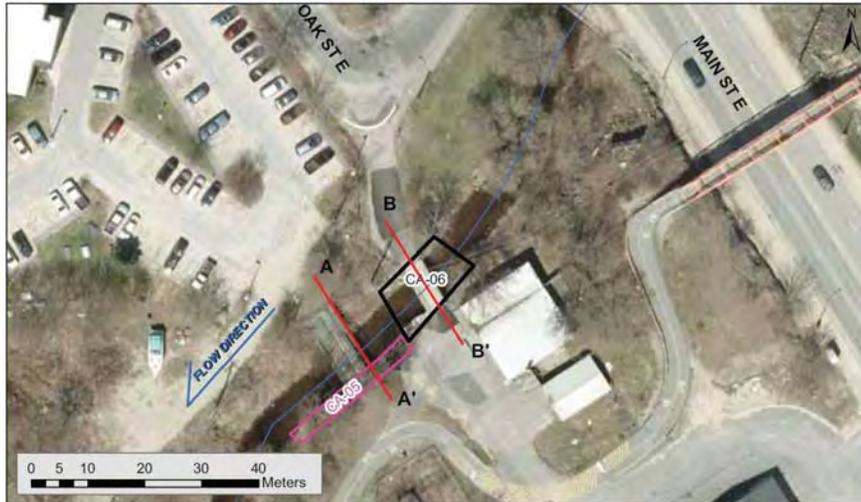
1. SITE LOCATION/DESCRIPTION
 Approximately 60m downstream of Main Street East near Oak Street East.
 This is a concrete bridge crossing that links Oak Street to the Kinsmen Way Trail through a property along the top of the left bank. Presumably this is an older bridge that has been repurposed as a pedestrian link.
 CA-05 is located immediately downstream along the left bank.

4. RECOMMENDATIONS
 Undertake a structure examination of the concrete structure prior to any works in order to utilize the existing retaining wall along the left bank.
 Remove old rail bridge at CA-05 and possibly at CA-06 if it is not deemed necessary to retain the crossing at this location.
 Re-grade the right bank to reduce in channel stresses and provide some floodplain access, plant with riparian plantings. Blend into banks upstream and downstream.
 With minimum setbacks to property along the left bank, a vertical armoustone wall with shrubs along the top should be constructed.

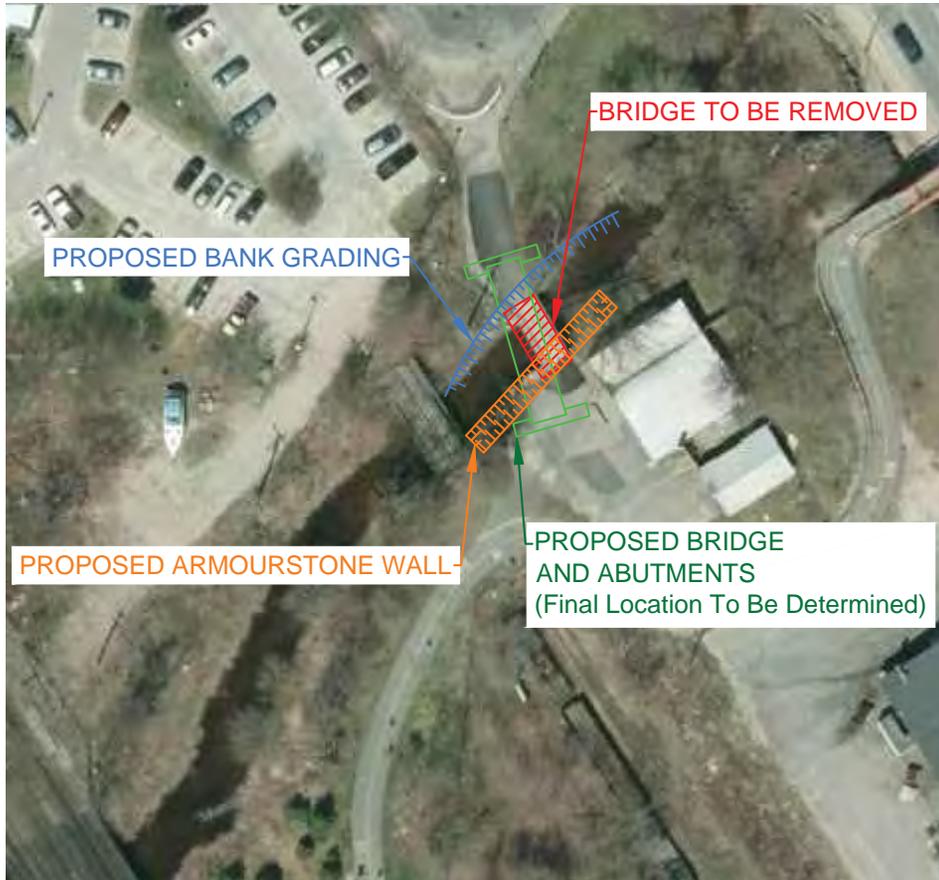
Option 4b

As 4a But With Removal of 2 Bridges and additional Bank Repairs

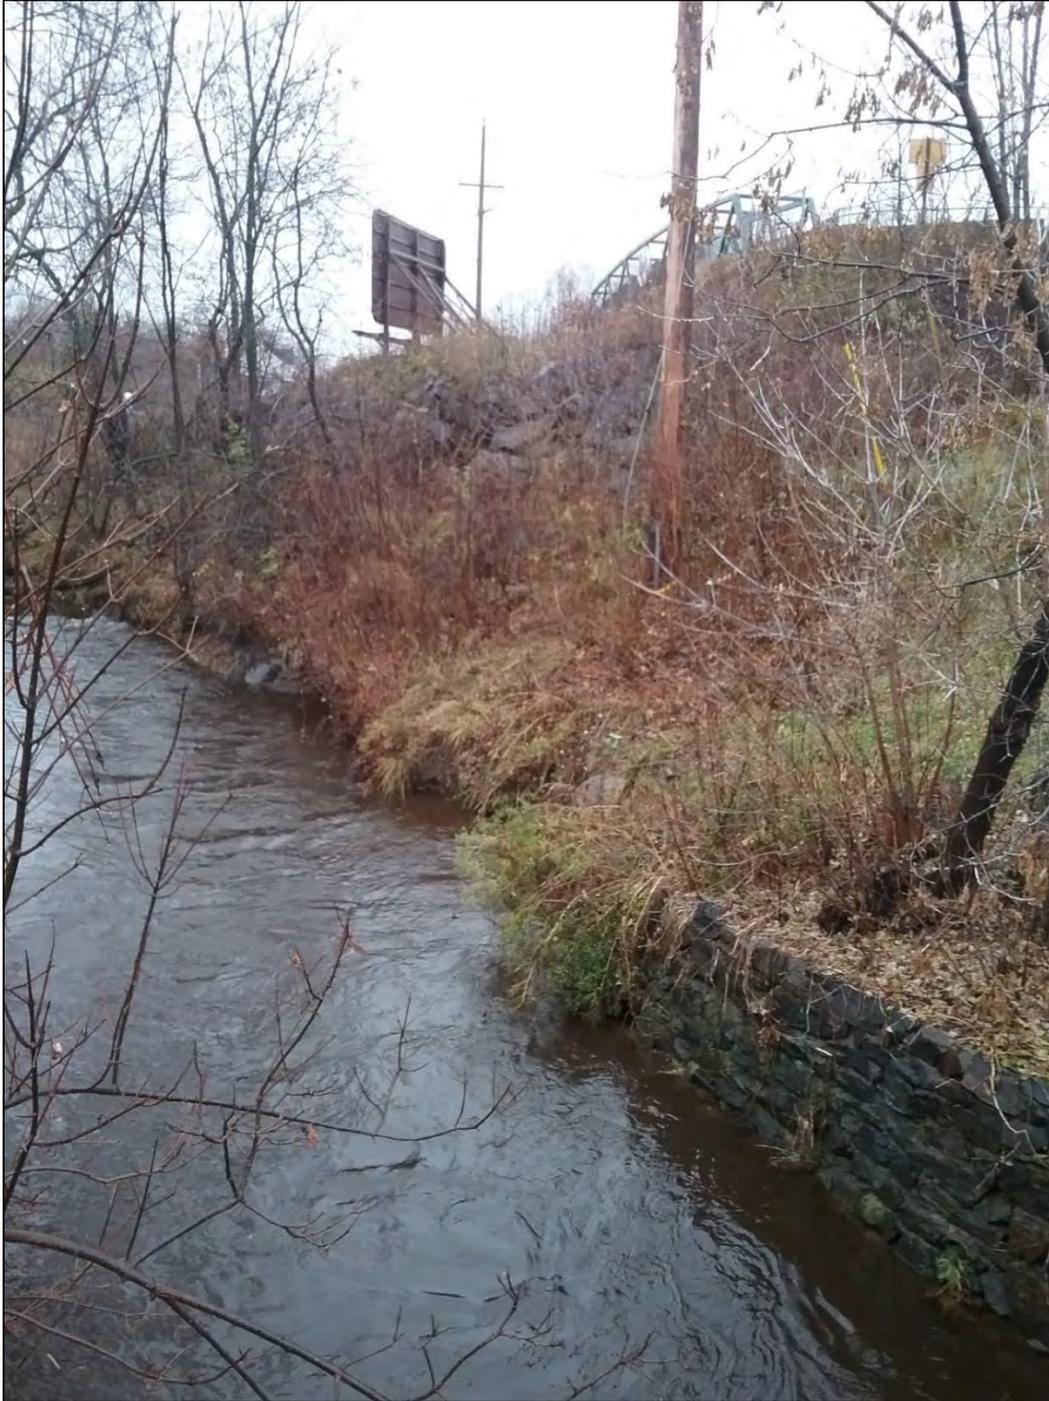
Photo 4: Representative photo of the G169X ecosite

To the northeast of the study area, upstream from the existing pedestrian bridge, there is an abrupt change in elevation along the southern creek bank where the substrates are coarse rock fragments and boulders. This landscape feature is beneath the west bridge abutments of the pedestrian-only Kinsmen Bridge which spans the Main Street East overpass. The rock fill supports moderate herbaceous growth and an area of artificially hardened shoreline can be seen in the foreground of Photo 4.

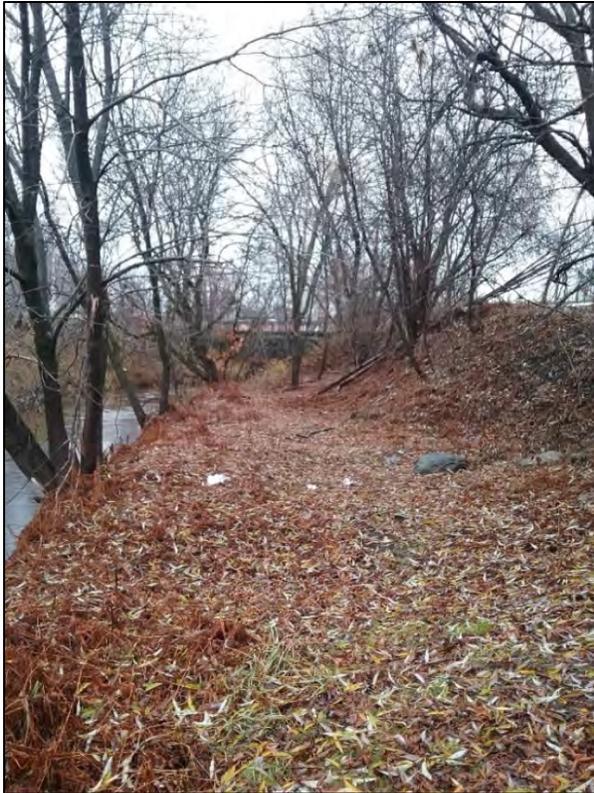
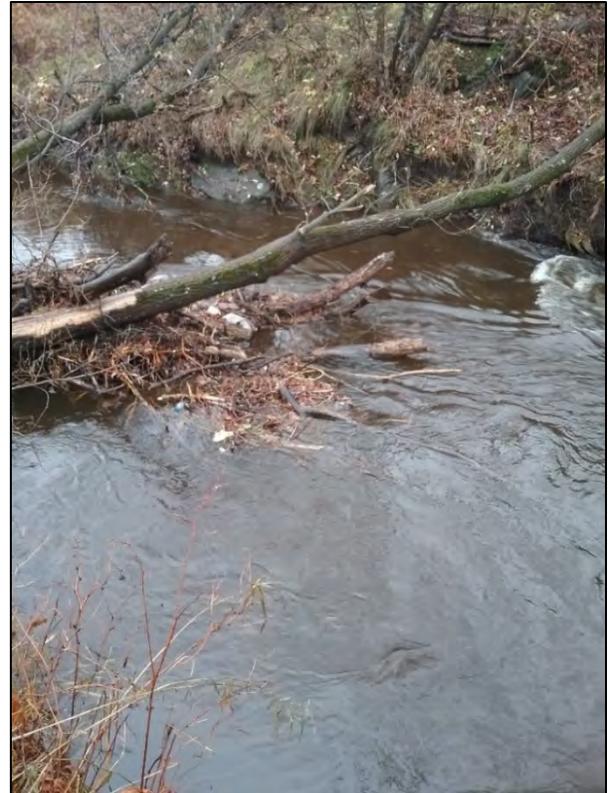
Photos 7 and 8: Terrace and riparian vegetation on south creek bank (left); in-stream woody debris upstream of pedestrian bridge (right)

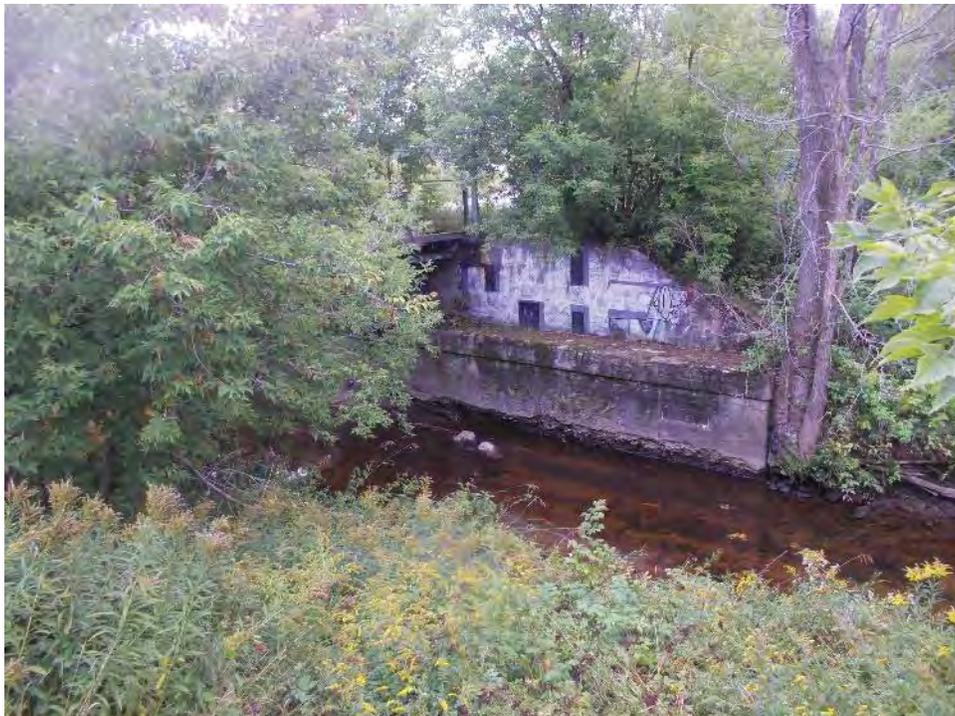
Figure 10: Railway Bridge Abutment, South Bank. Facing Southeast.

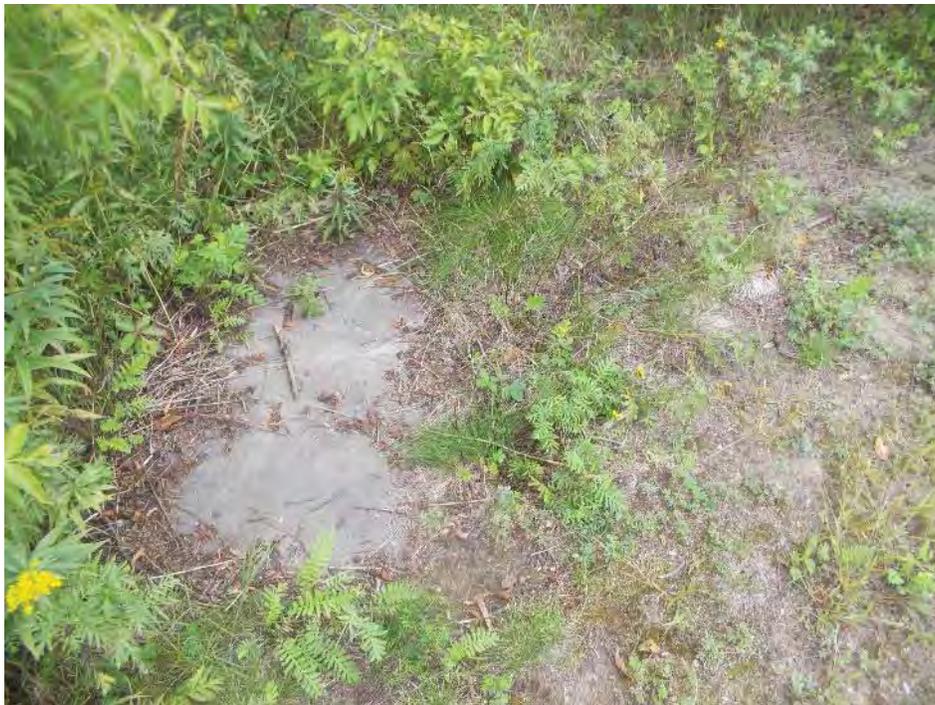
Figure 12: Chippewa Creek Oak Street Repair. South Bank Project Area. Note Exposed Concrete under the Ground Cover. Facing North.
